LIFERAFT REPACKING ISSUE - USE OF IMPROPER TAPE TO SEAL CONTAINER

APRIL – 2003

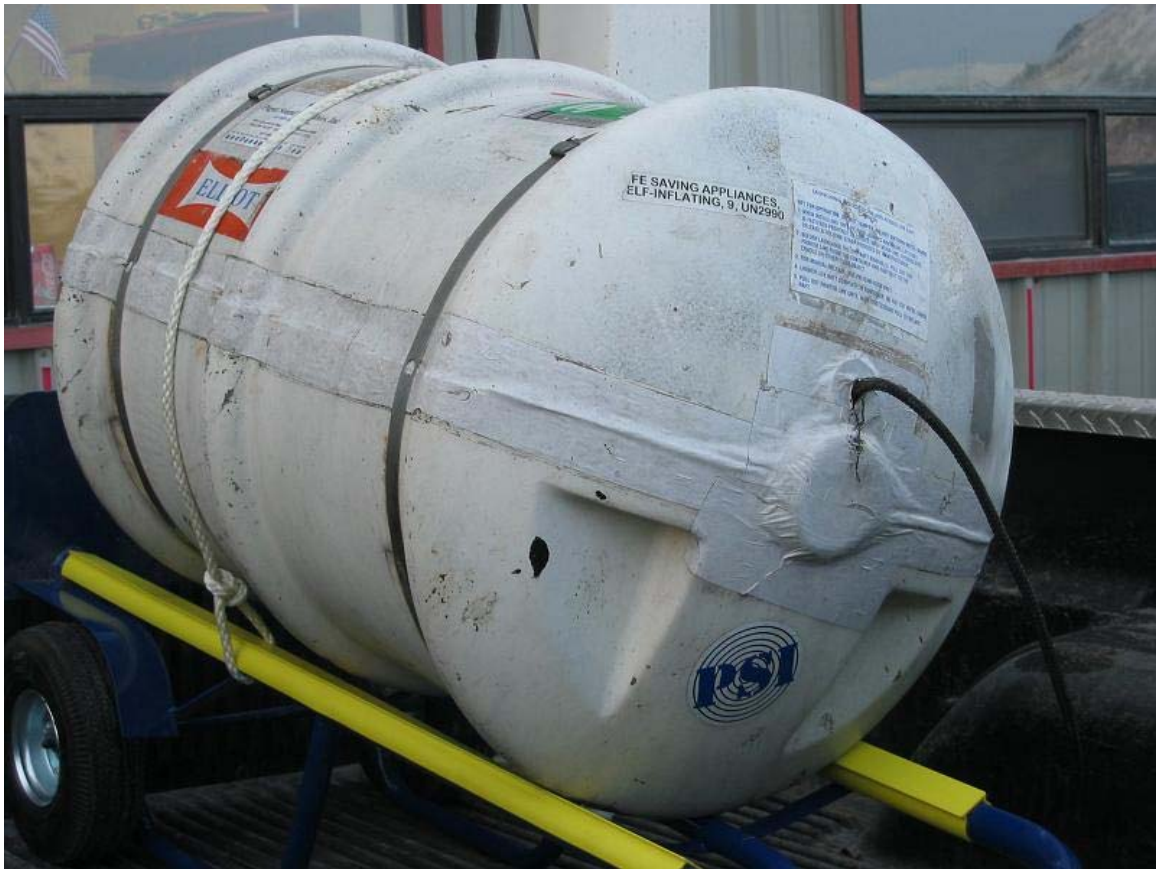
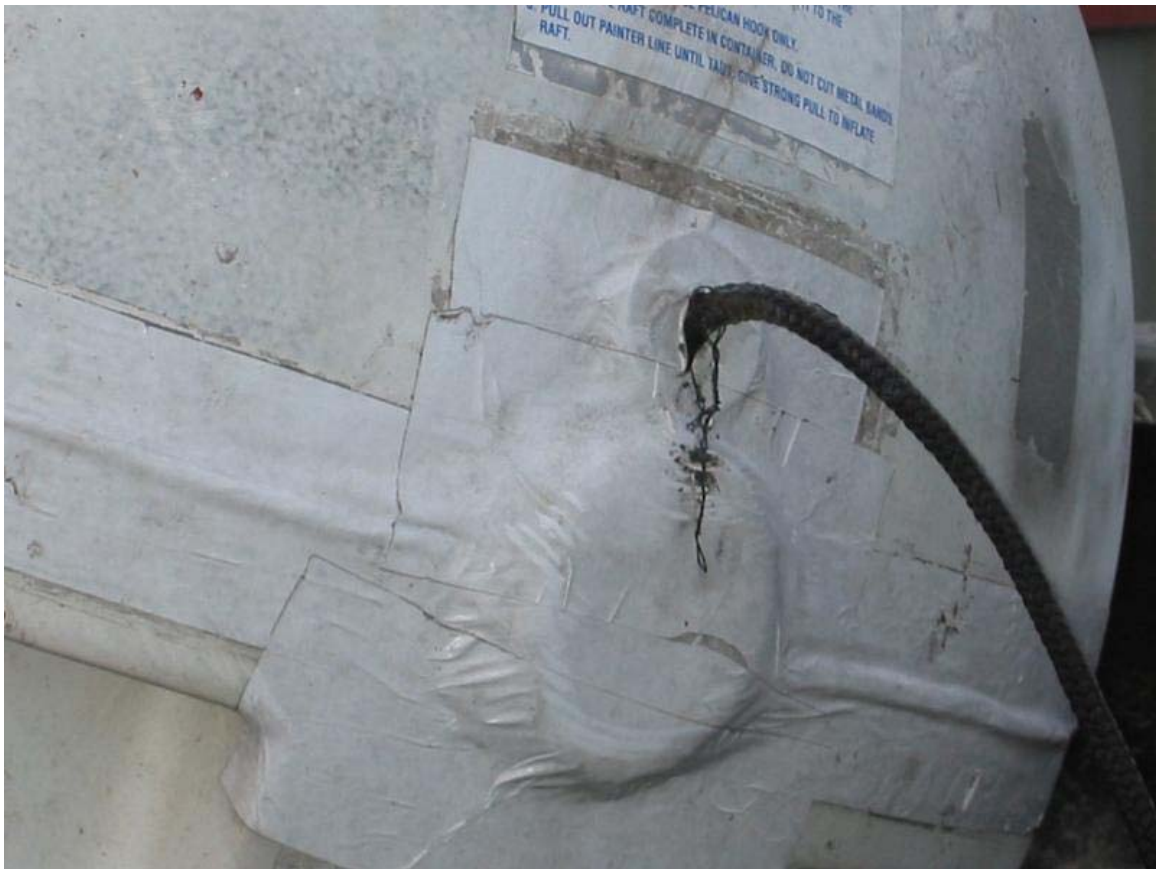
Problem: At least one liferaft repacker was using improper (i.e. too strong) tape to seal liferaft containers. This tape was placed over the plug that seals the sea painter entry/exit point in the cannister. Also, the knot typically tied on the sea painter just inside the plug (through which the liferaft sea painter passes) was not tied.

1. The tape was really the critical issue - you could actually lift the liferaft in it's cannister by lifting up on the sea painter - the plug did not pull out as it was supposed to, allowing the sea painter to freely pay out. This was due to the fact that an industrial grade reinforced heat shrink tape was used and was installed over the plug. Had this liferaft been deployed in it's original condition, the liferaft would have floated free of the boat, but since the sea painter would not pay out, the liferaft would not have inflated.

2. Lack of a knot behind the plug - the knot allows the plug to be pulled out as the sea painter pays out - allowing the sea painter to pay out freely and avoid jamming/tangling inside the cannister. The plug in this case is a hard rubber style that will not break apart as some of the foam ones do if pulled with any tension. If the hard rubber plug remained in the side of the liferaft cannister, it would really be easy for the painter line to tangle and jam inside the cannister, stopping the line from paying out and the liferaft from ultimately inflating.

Solution: Pay particular attention to the type of tape (if used) on the liferaft cannister. If it impedes the plug & painter from operating as it should (i.e. easily coming out), then it should be removed from the vicinity of the plug & painter. In all cases, the fishing vessel crew did not notice this as they had assumed that the repacker had done the right thing.
